Failure Analysis of a Gas-Nitrided 15-5PH Steel

J. L. Golden, Ph.D.
ASM Houston Chapter / Failure Analysis Seminar
Houston, TX
03 April 2012

ISS 2007 Configuration: Solar Alpha Rotary Joint (SARJ) Locations

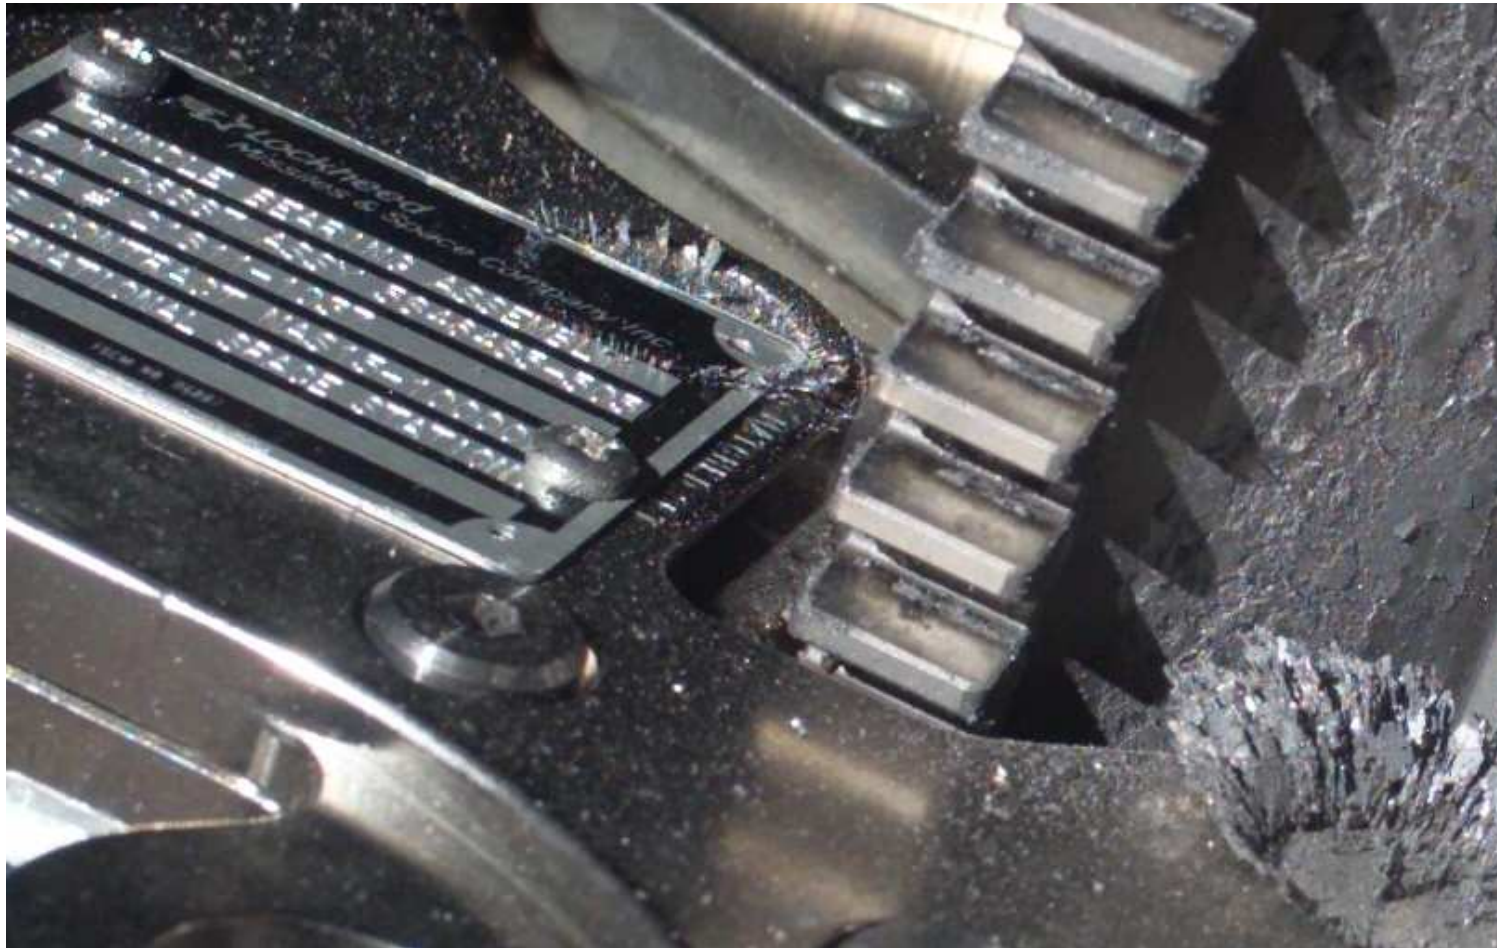
Initial Examination of Starboard SARJ Race Ring Damage

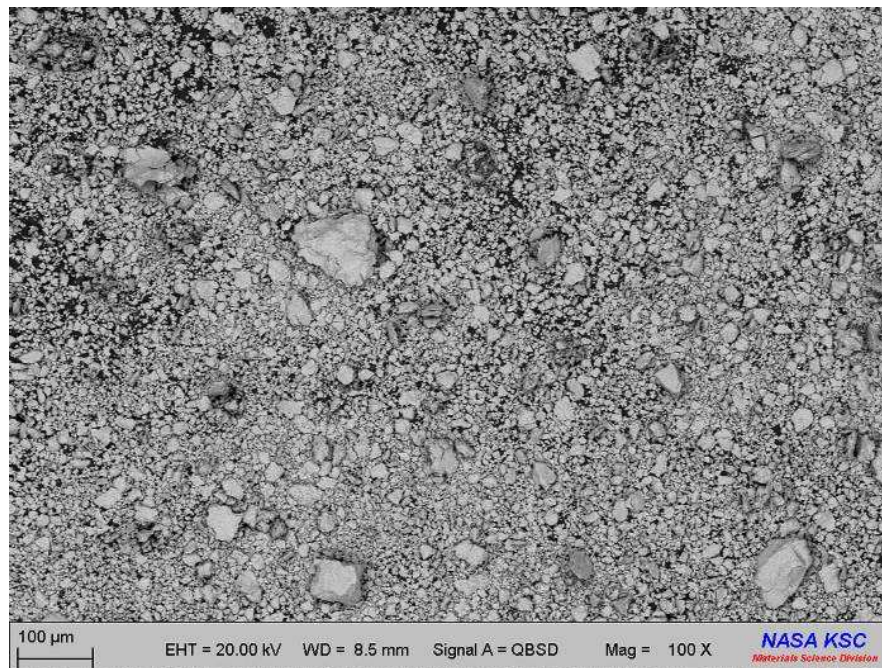
Representative area of
“fine” debris (< 100 μm)

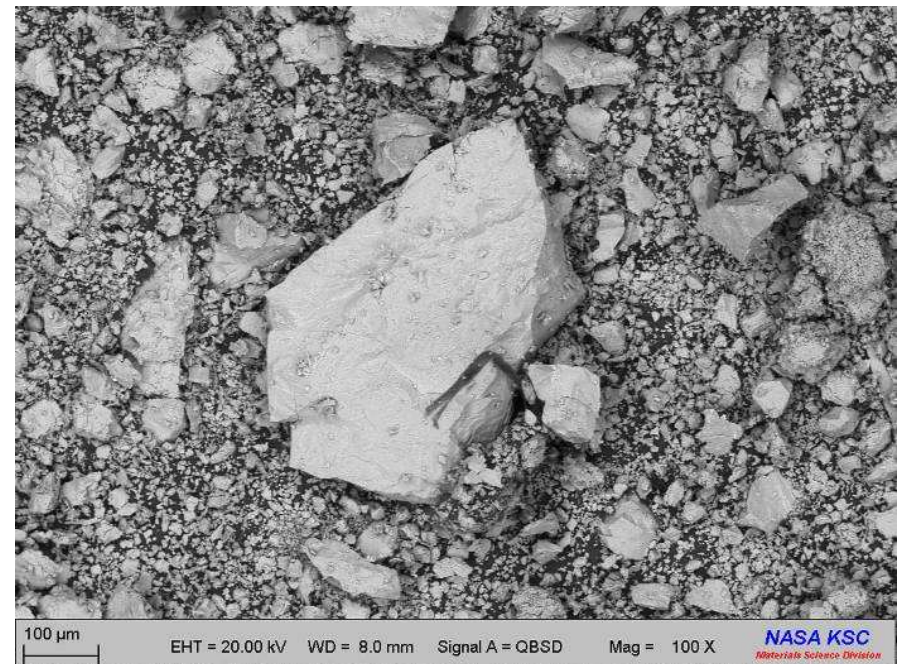
Representative area of all debris;
broad particle size distribution

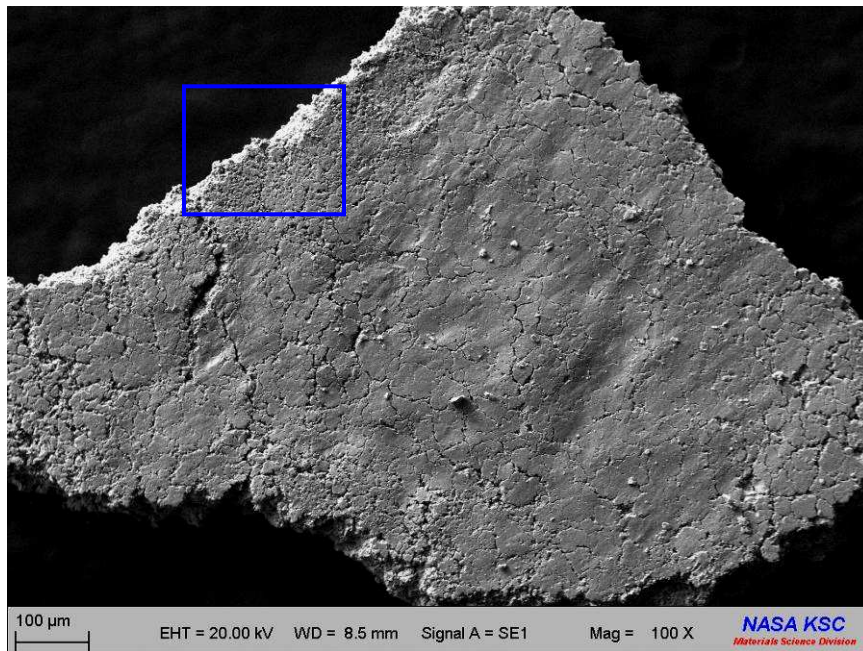
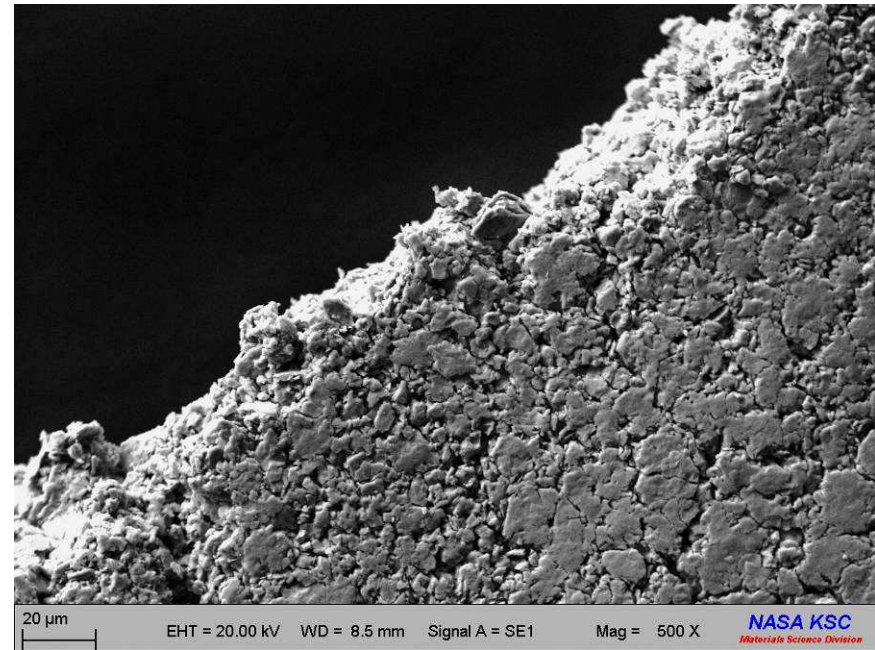
Nitrided 15-5 PH agglomerated fragment from Tape 31 imaged under high vacuum.
Reference magnifications: 100X (left), 500X (right)

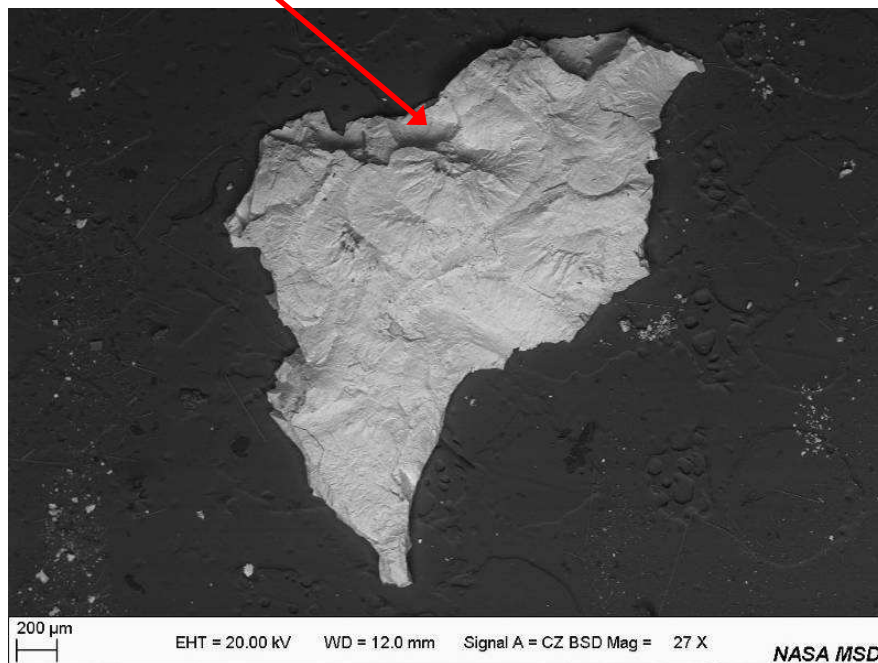
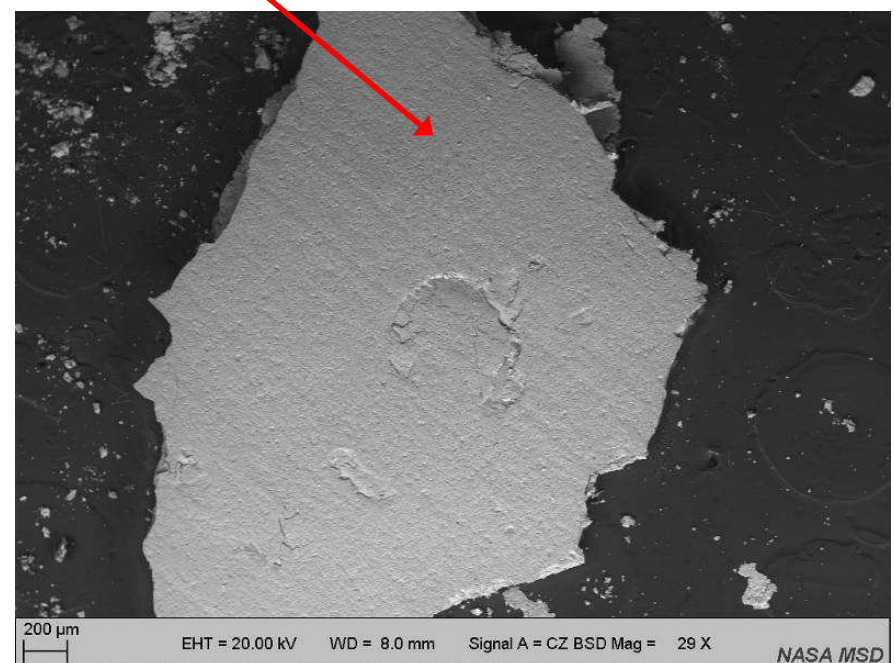
- **Physical Characteristics of the Failure Debris – Cont.**
 - **Particle Types – “Large Chip” Particles**
 - Original surface typically visible on one side (right photo)
 - Low cycle subsurface fractures on the other (left photo)
 - Thickness typically at or near nitride layer thickness

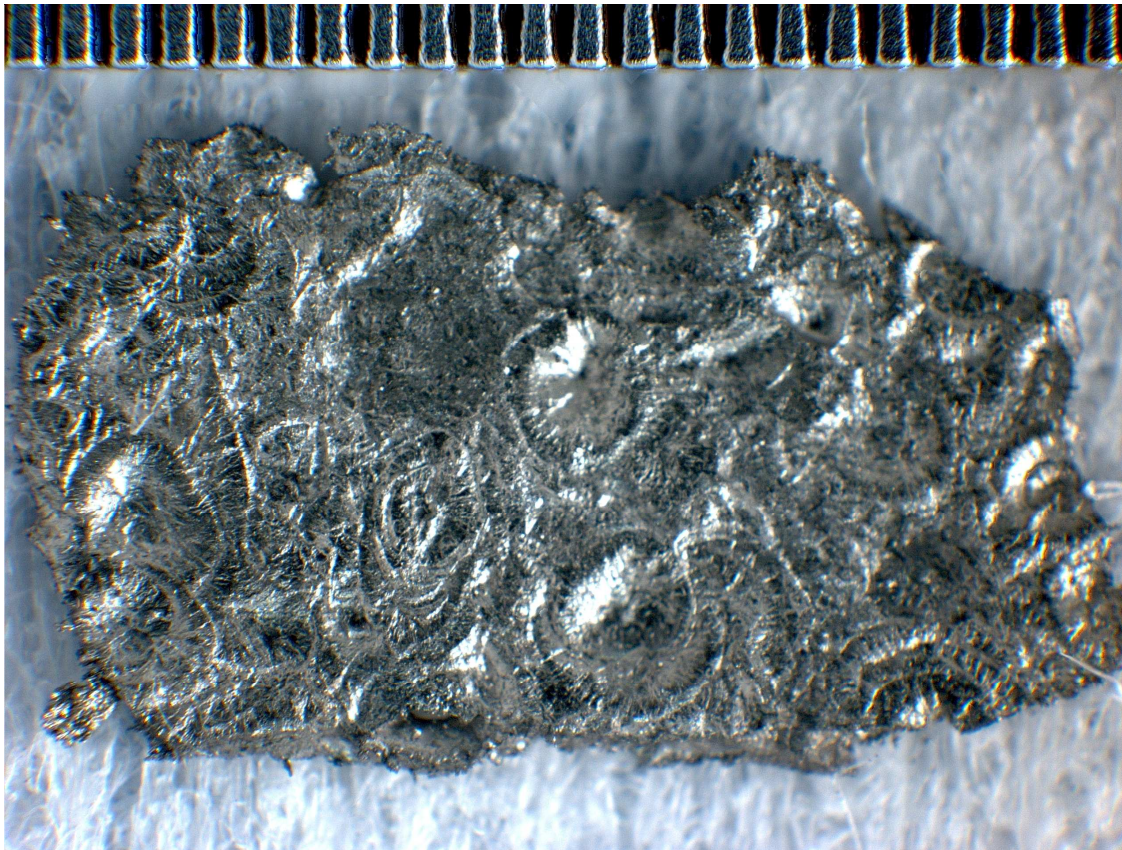
- Largest particle located was ~3mm x ~5 mm.
- Particle thickness was about 150-170 μm , essentially equal to the nitride layer thickness.
- Numerous subsurface fracture initiation sites were observed, indicating a low-cycle fracture phenomenon took place.

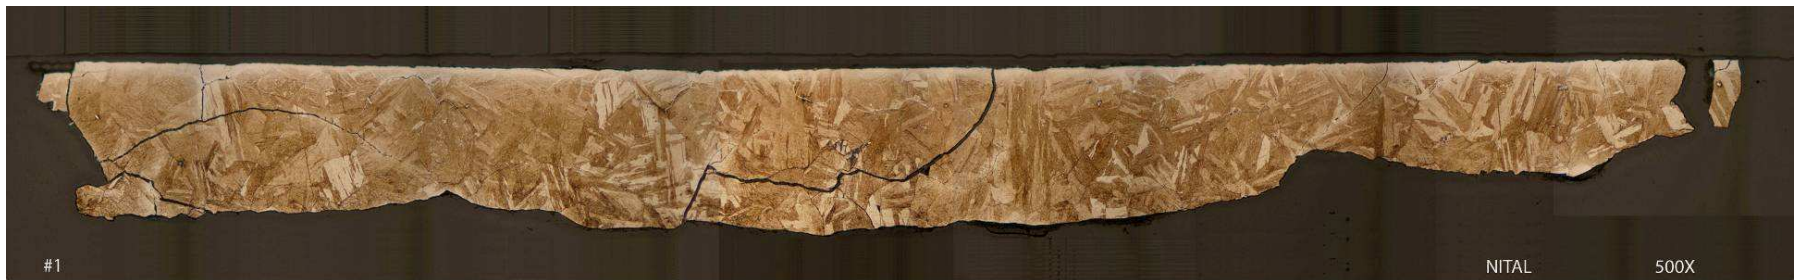
Typical large “chip” cross section showing:

- Maximum thickness essentially equivalent to nitride layer thickness, indicating failure is occurring near the case/core interface;
- Evidence of residual “white layer”, in excess of the 8 μm maximum required.
- Fracture lines are transgranular, showing no preference for the intergranular networking observed near the surface.

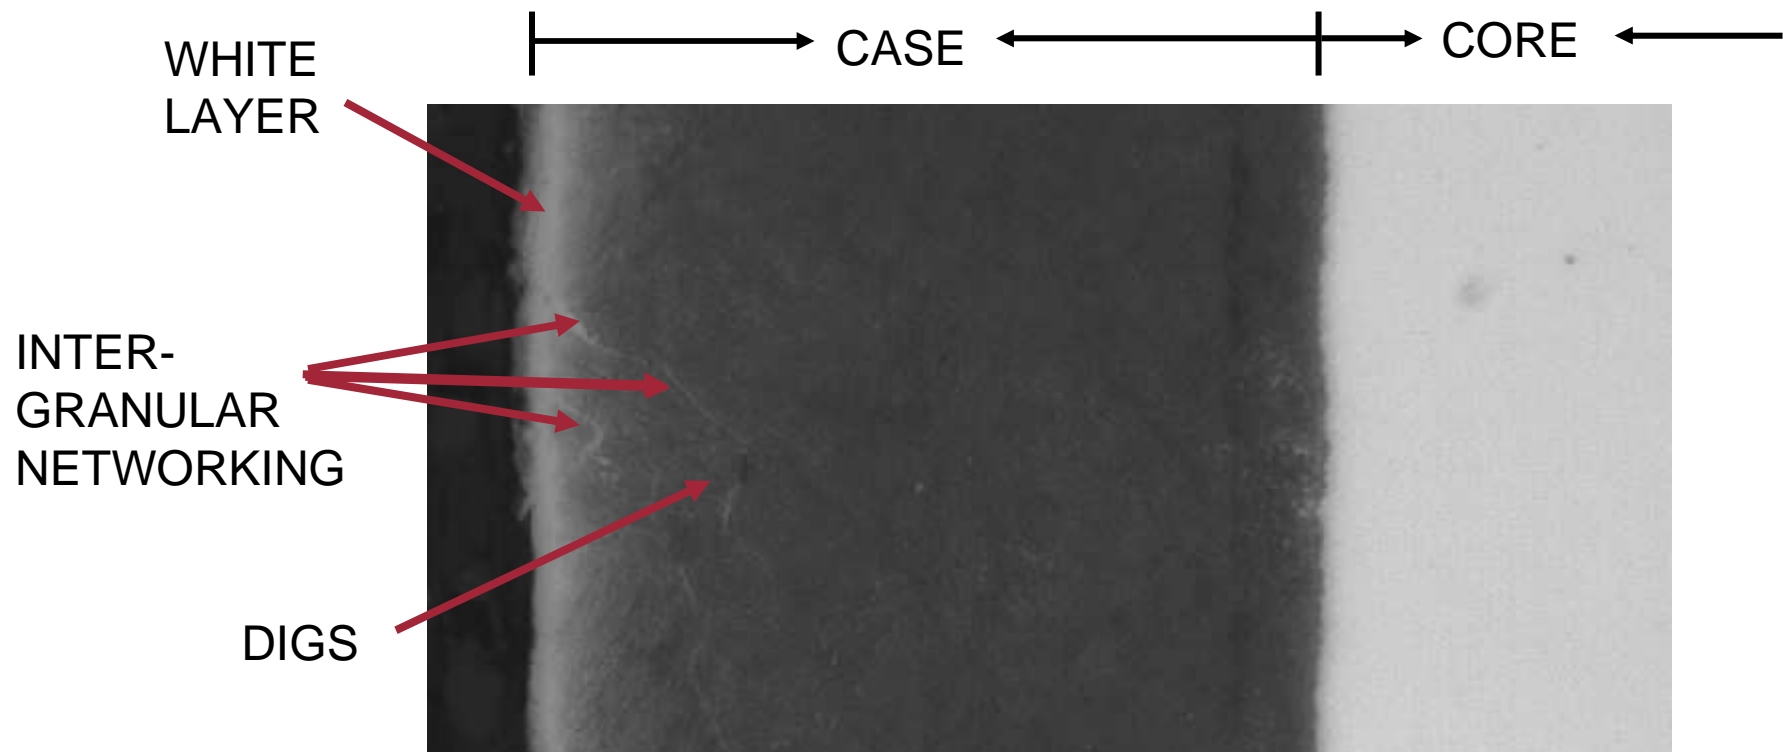
- **How did we miss the DIGS originally?**
 - They were right in front of us, but not recognized as an issue.
 - Micrograph below is from original test coupon inspection.

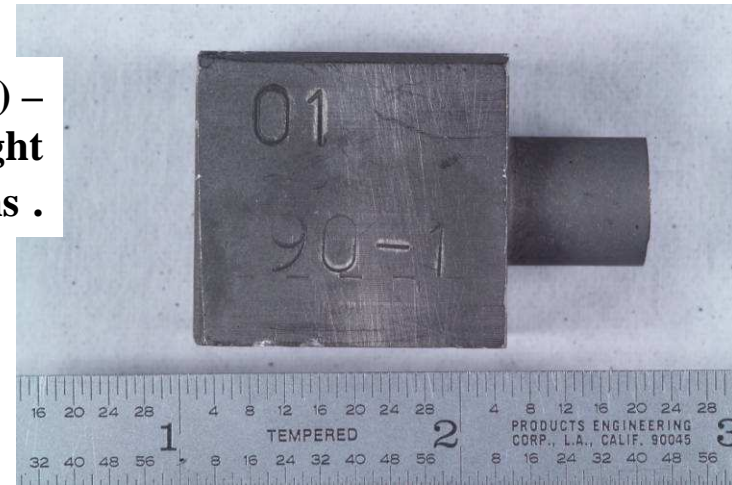
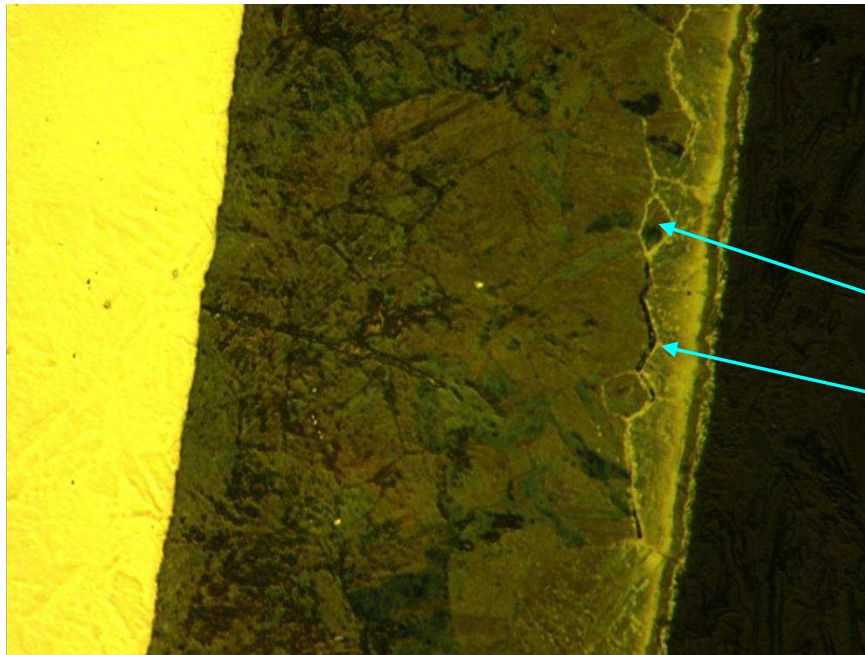
**Metallurgical Evaluation of SARJ Race Ring
S/N 4
Sample Coupon (Polished, Etched and View
@1000X)**

Networking

Intergranular separations
(appear like cracks)

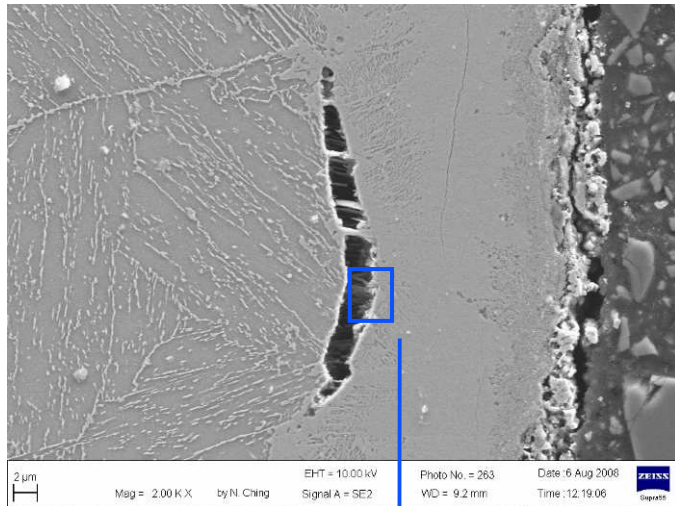
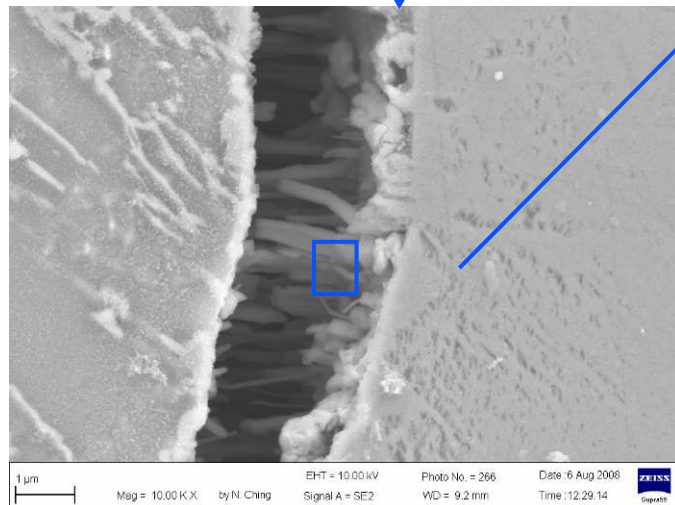
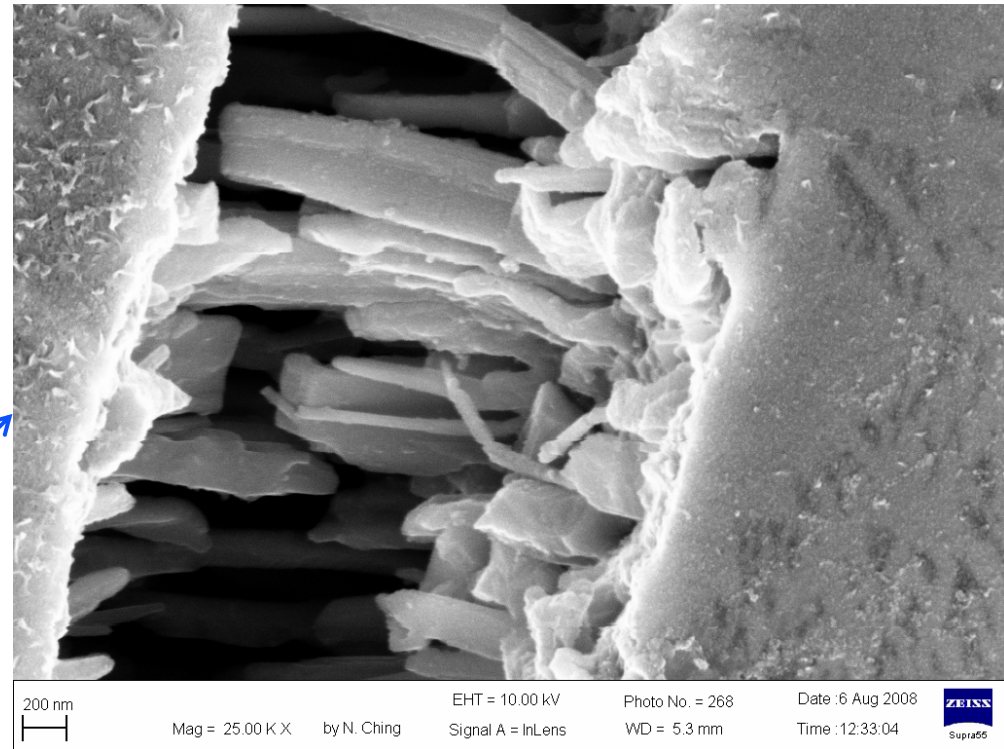
Polished metallographic sample exhibiting DIGS.
The degree of porosity and the type scaffolding structure remaining inside each DIGS varies and at times appears as a nanostructure.

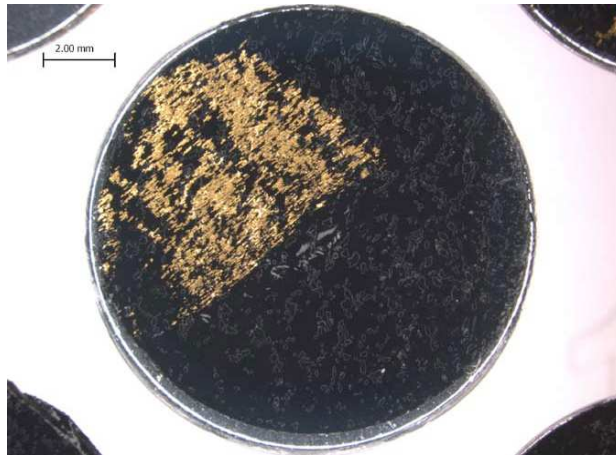
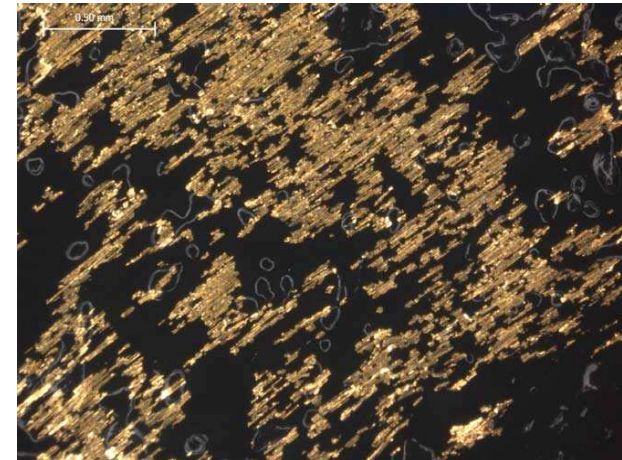
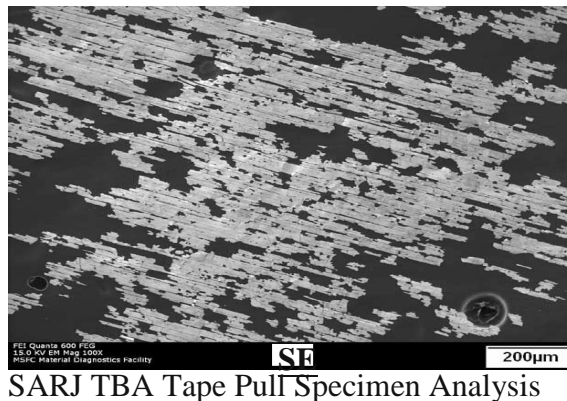
TBA 1045, Datum A, Test #2, Carbon Tape

- Gold coating was easily removed from trundle bearing roller surfaces using carbon tape, and was generally segmented into strips of dimension consistent with the as-machined surface finish.

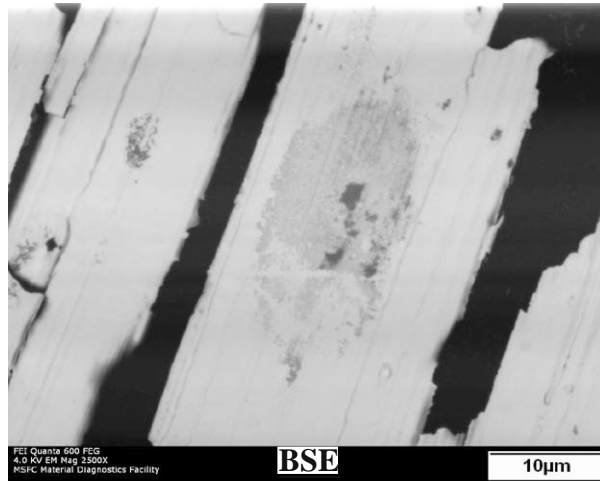
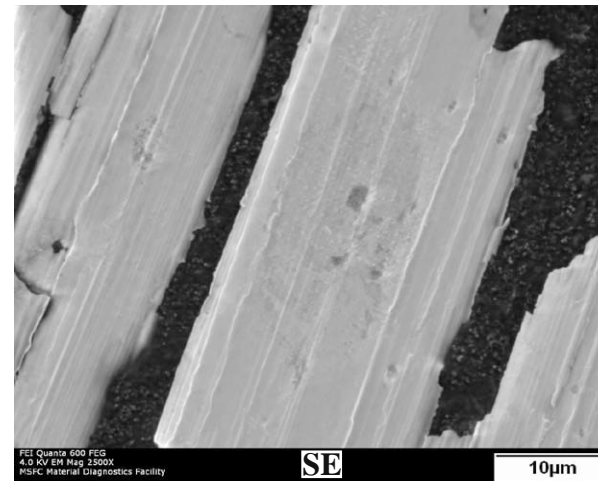
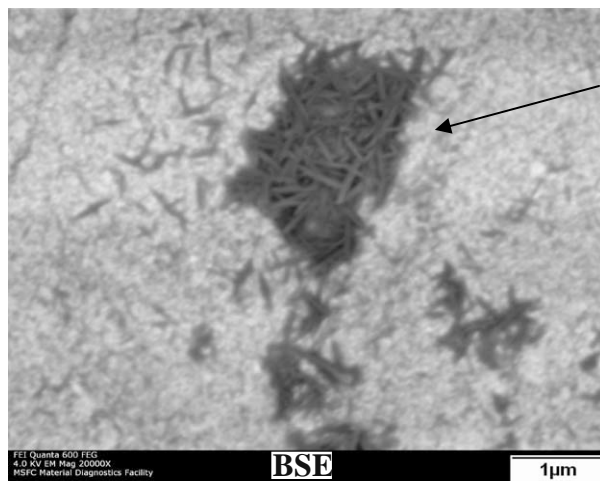
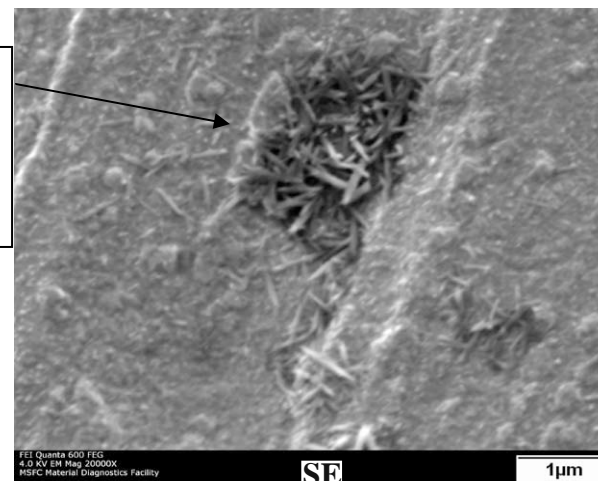
TBA 1005, Outer 45, Test #1, SEM

Iron Oxide
(by
elemental
analysis)

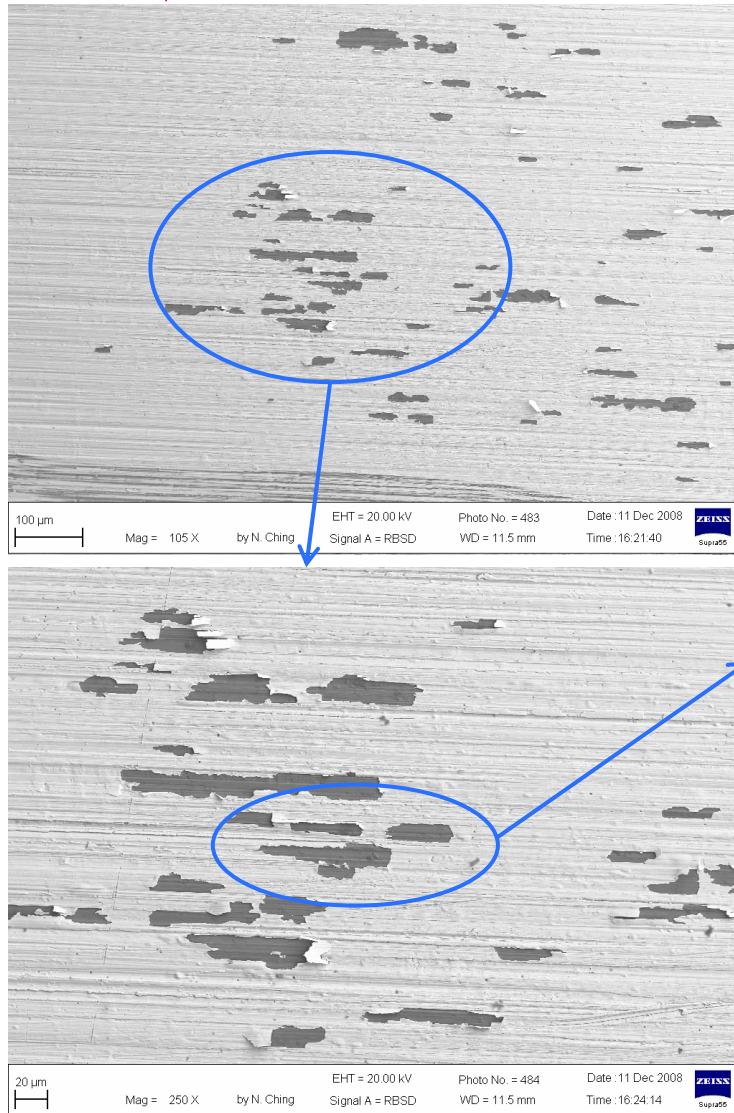
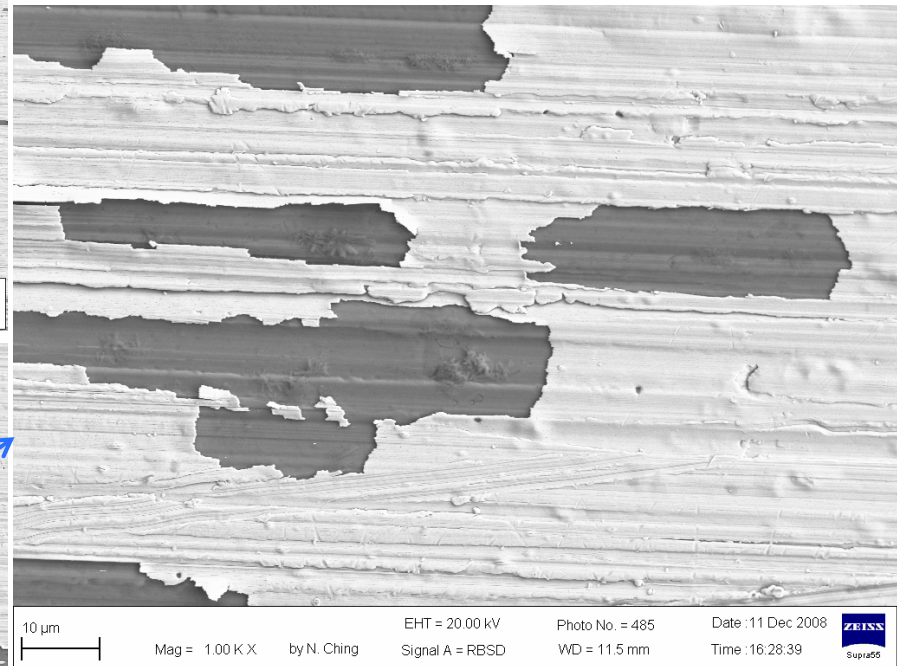
➤ Freshly gold-plated 440C after 21 days of 95%RH at 125°F.

➤ Adhesion failure mode is consistent with that observed with trundle bearing rollers.
